## (OPERATION OF A HAYNES ALLOY NO. 25 FORCED CIRCULATION LOOP TO STUDY THE EFFECTS OF HYDROGEN IN A SIMULATED SUNFLOWER SYSTEM)

*by R. C. Schulze and D. B. Cooper*

NATIONAL AERONAUTICS AND SPACE ADMINISTRATION • WASHINGTON, D. C. • MAY 1965

NASA CR-225

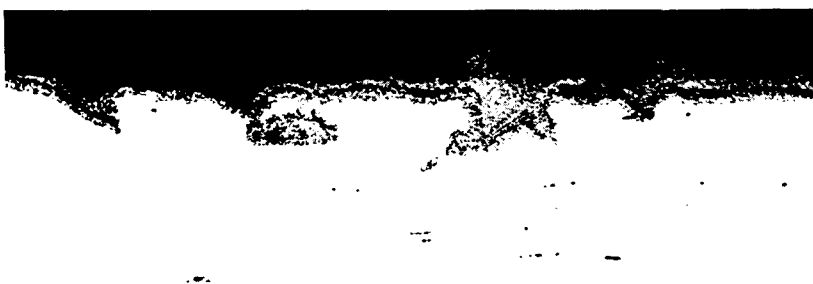
Figure 33. I.D. Surface of Specimen Removed from the Middle Region of the Boiler (Section 12, Thermocouple No. 6).

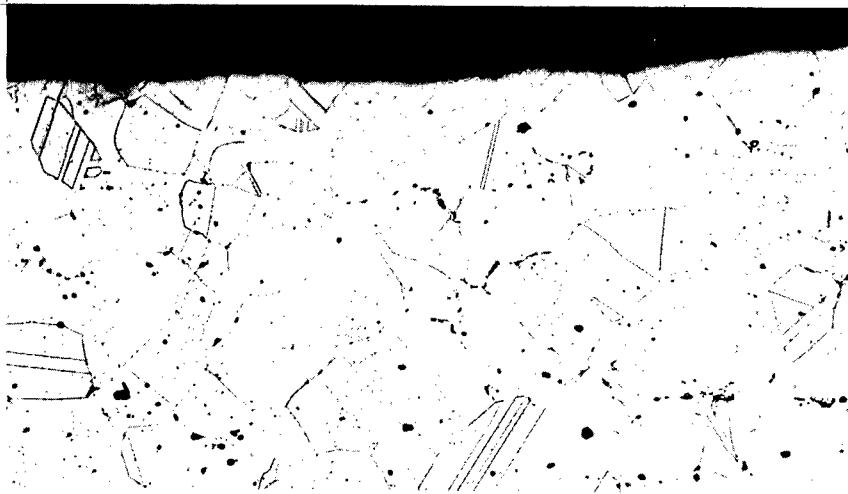
The middle of the superheater (Section 22 and 23) also contained a deposit similar in nature, although, the concentration of the deposit was not as heavy. In general, the deposit appeared to follow the contour of the swirl wire. Figure 40, (macrograph of sections 22 and 23) shows the overall appearance of the I.D. surface of the tubes. Figure 41 (Section 22, thermocouple No. 21) shows a general appearance of the deposit. In the middle of the superheater the deposit reached a maximum thickness of 0.010 in. in thickness. Scattered areas of deposit were also found in the outlet region of the superheater. The thickest deposit in this region was found near a weld area (Section No. 25, weld). As shown in Figure 42 (Section No. 25, weld) the deposit was crescent shape and .014 inch thick.

Figure 42. Appearance of Deposit Found on the I.D. Surface Near the Weld Area of the Specimen Removed from the Outlet Region of the Superheater (Section No. 25, Weld).

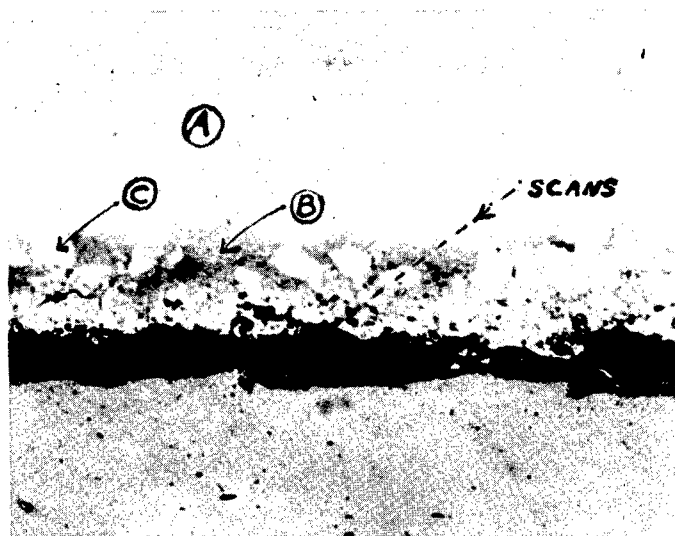
Figure 46. I.D. Surface of Specimen Removed from Section No. 16, Thermocouple No. 11, Showing the Microprobe Scan Path and Areas Analyzed.

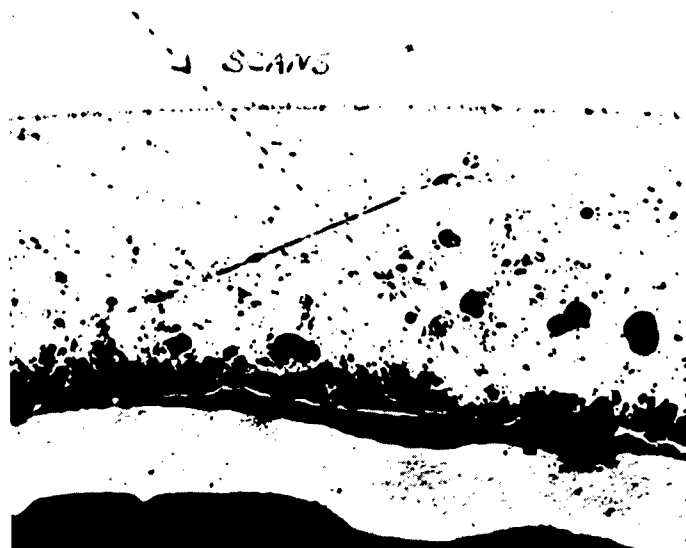
The analyses conducted on the two specimens from the boiler outlet region support the results obtained on wet chemical analysis of the deposits removed from the inside tube wall. However, three different compositional areas were found in the deposit along the surface of specimen Section No. 17, thermocouple No. 13. The grayish appearing phase is similar in composition to the corrosion layer found along the surface of the specimen Section No. 16, thermocouple No. 11 (Figure 46). As shown in Table 18, this phase is high in cobalt and tungsten with only small amounts of chromium and nickel. The white areas (marked C in Figure 47) within the deposit were found to be essentially the base metal depleted of chromium, whereas the edge of the deposit (marked B in Figure 47) was found to be essentially base material depleted in tungsten and nickel.

Figure 47. I.D. Surface of Specimen Removed from Section No. 17, Thermocouple No. 13, Showing the Microprobe Scan Path and Areas Analyzed.

From these results it appears that the surface of the specimen Section No. 17, thermocouple No. 13 suffered a leaching type of attack. And, a deposit of corrosion products filled the void areas left by the leaching of base material.

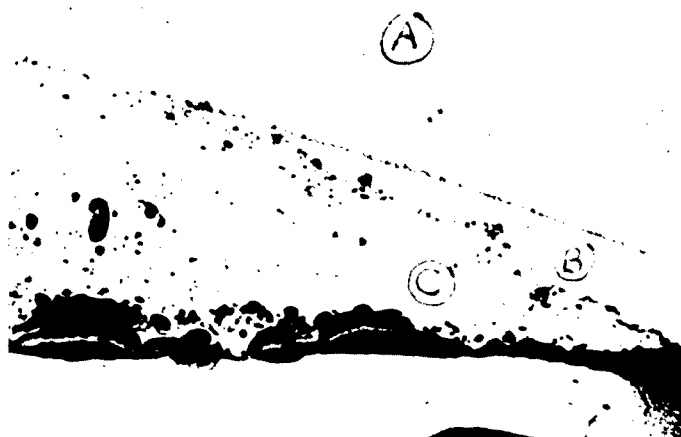
Figure 48. I.D. Surface of Specimen Removed from Section No. 20A, Thermocouple No. 18, Showing the Microprobe Scan Path.

Two areas of different composition were found within the deposit on the specimen Section No. 20A, thermocouple No. 18. As shown in Table 18, the bulk of the deposit (Figure 48 and marked C in Figure 49) was predominantly nickel with about 25 to 27 percent chromium. Only minor amounts of tungsten, iron and cobalt were found. However, another phase, (marked B in Figure 29) was found that was almost pure chromium (98-99 percent). Cobalt, tungsten, iron and nickel were found only in small or trace amounts. The results of the analysis of the specimen Section No. 22, thermocouple No. 21 were approximately the same. However, the chromium-rich phase was present in a greater quantity within the deposit. Also, there was not the same amount of distinction between the phases as was found in the specimen Section No. 20A, thermocouple No. 18.

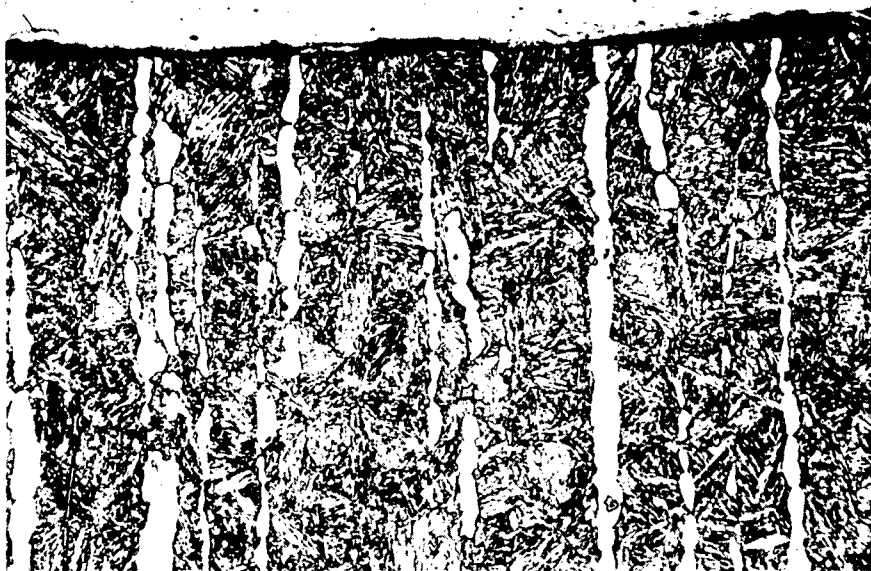
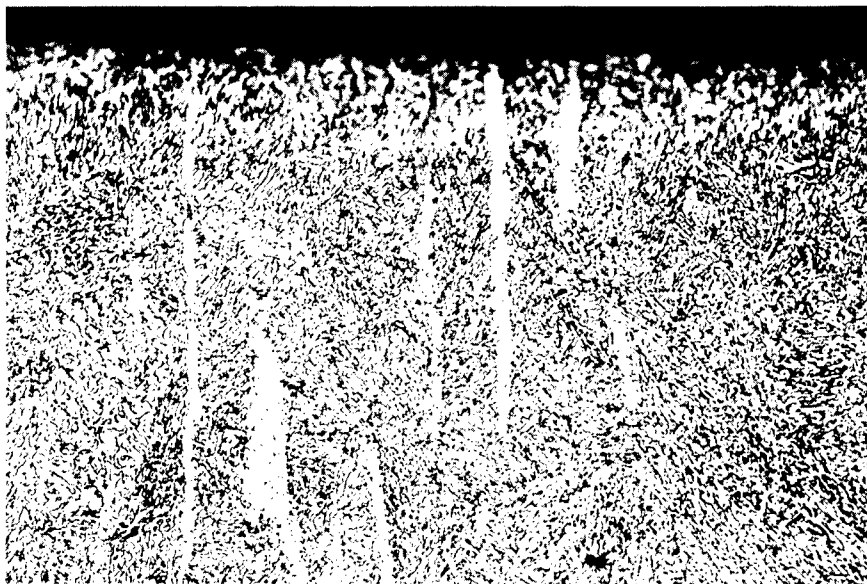
Figure 52. Condition of the Edge of the PH15-7Mo Erosion Specimen Heat Treated to the Condition RH 950.

Figure 52 shows before and after test photomicrographs of the PH15-7Mo erosion specimen heat treated to the RH 950 condition. As shown by the photomicrographs, the edge of the specimen was relatively unaffected by the exposure to high velocity mercury vapor. However, as can be seen, the microstructure of the specimen in the after test condition changed from an acicular martensitic structure to that of a tempered martensite. Also as shown, carbon diffused into the ferrite stringers.

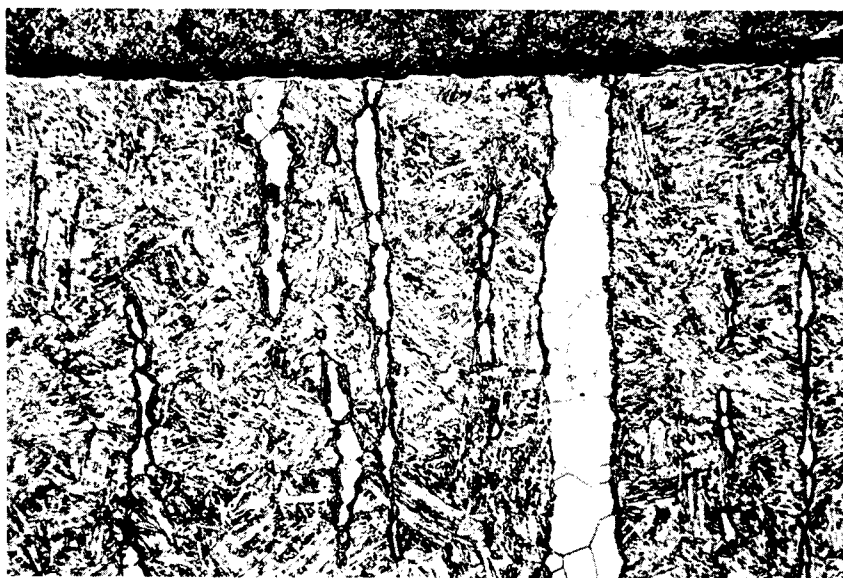
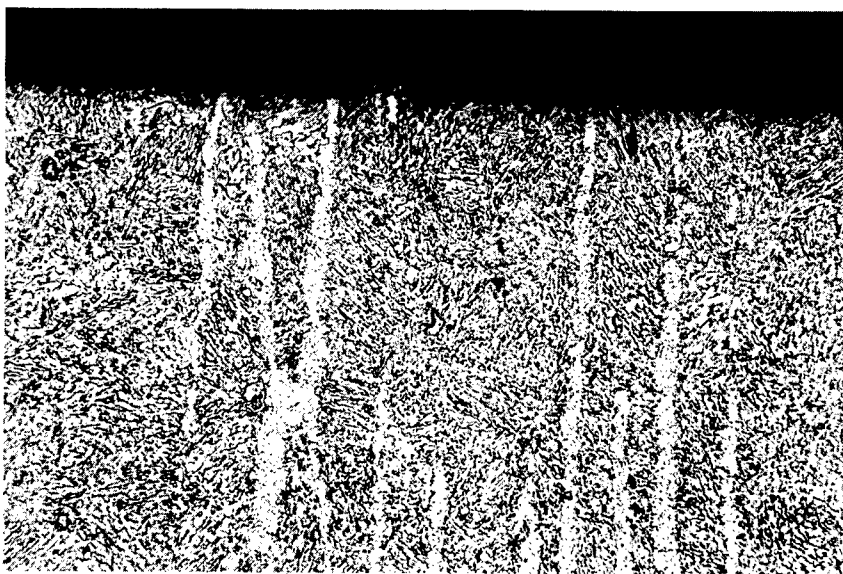
Figure 53. Condition of the Edge of the PH15-7Mo Erosion Specimen Heat Treated to the Condition TH 1050.

Photomicrographs in the before and after test condition of the PH15-7Mo erosion specimen heat treated to the TH 1050 condition are shown in Figure 53. As shown, the surface of the specimen was relatively unaffected by the exposure conditions. Also, the microstructure of the specimen in the after test condition changed as compared to the structure in the before test condition. The changes which occurred are essentially the same as those discussed for the PH15-7Mo erosion specimen heat treated to the RH 950 condition.

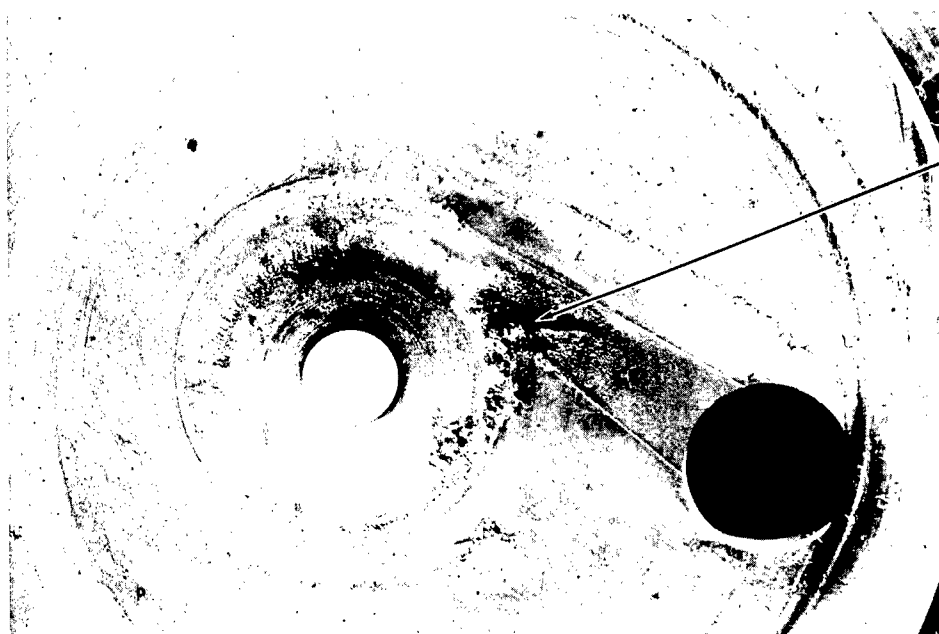
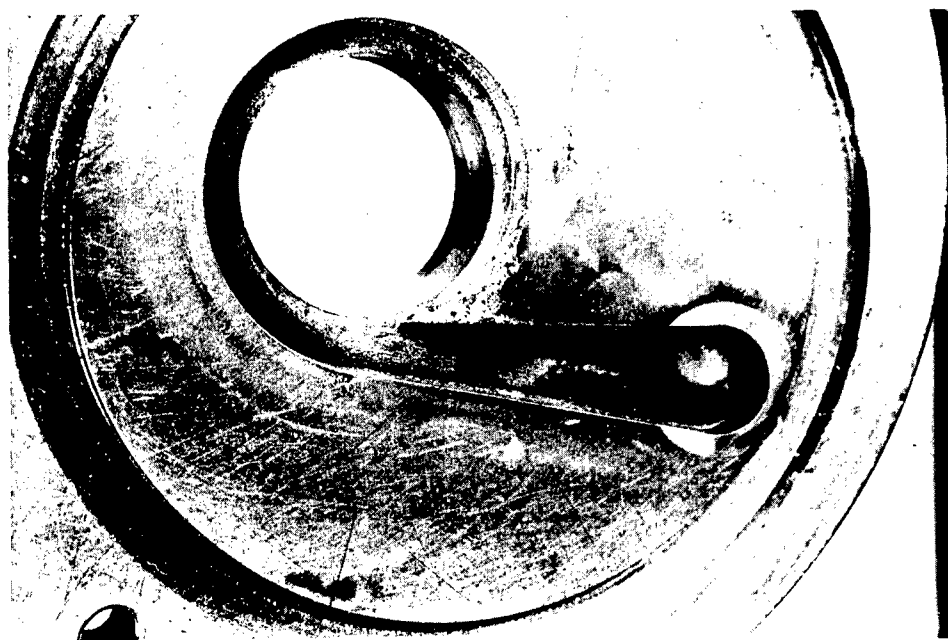
The final loop component to be examined was the centrifugal pump, which was fabricated from Type 316 stainless steel. The pump head was dismantled and examined visually for any possible damage. The pump components examined are shown in Figure 55. Evidence of cavitation damage was found only on the volute tongue. Figure 56 shows macrographs of the tongue and the extent of damage incurred. Sections were removed from the top part of the tongue (Figure 56) at the damaged area. These sections were then mounted and polished for metallographic examination.

Area where metallo-  
graphic specimen  
was removed.

Figure 56. Macrograph of Centrifugal Pump Body Showing the Extent of Damage Incurred.

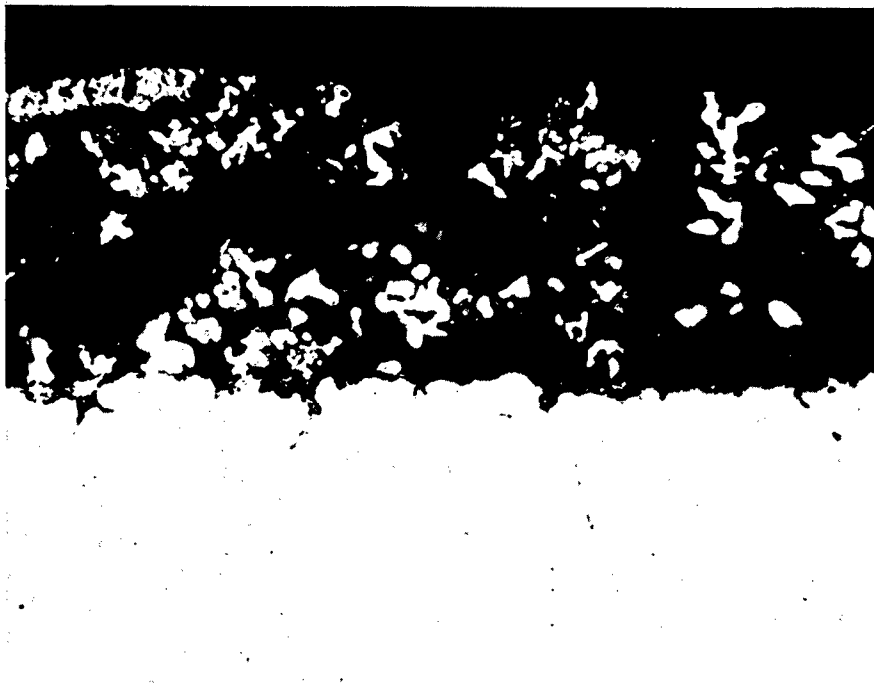
In addition to the cause of failure, the specimens were also examined for the extent of corrosive attack found. In general, the I.D. surface on each specimen was found to have undergone a combination of layer, crevice, and depletion attack to a maximum depth of 0.003 inch. Figure 62 is typical of the corrosive attack found. Examination of the surface of the specimen removed from the inlet end of the section revealed a deposit about 0.015 in. thick. Figure 63 shows the appearance of the deposit. Unfortunately, there was not enough deposit present in the section of tubing to obtain an analyses.

Figure 62. Appearance of the I.D. Surface Near the Failure which Occurred in the Boiler After 3876 Hours.

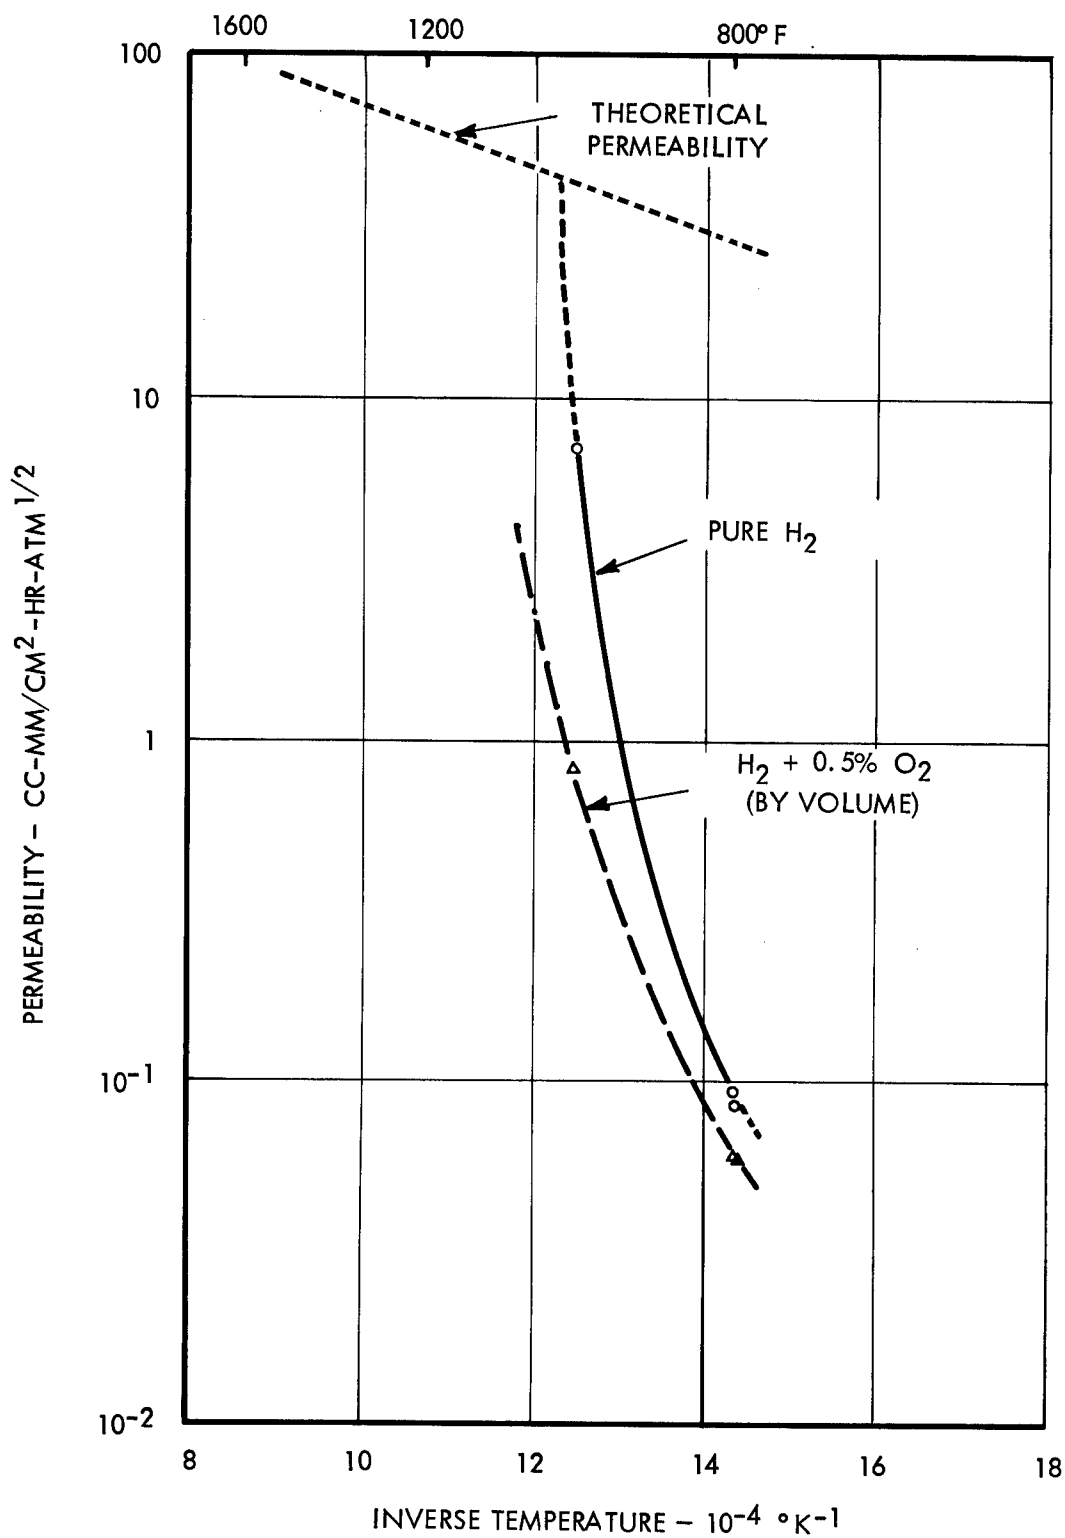
A tube test specimen was employed in this study. The experimental apparatus and method of analysis were identical to those previously described (10). The experimental results are summarized in Figure 64 where the permeability of pure and oxygen contaminated hydrogen through columbium is presented. As the temperature increases (approaching  $1200^{\circ}\text{F}$ ) the permeability of uncontaminated hydrogen approaches the high value predicted by diffusivity and solubility data. The presence of 0.5 percent (volume) oxygen in the hydrogen produced a slight decrease in the hydrogen permeability. The relatively small effect produced by the rather large degree of oxygen contamination, particularly at the lower test temperature, suggests that the small amount of oxygen adsorbed on the tube wall does not represent a significant factor controlling the low permeability at low temperature. Also, the results indicated that improved cleaning or bake-out methods to remove adsorbed oxygen would not improve the permeability of columbium at temperatures of  $600^{\circ}\text{F}$  and lower to any significant degree.

FIGURE 64 PERMEABILITY OF HYDROGEN AND OXYGEN CONTAMINATED HYDROGEN THROUGH COLUMBIUM

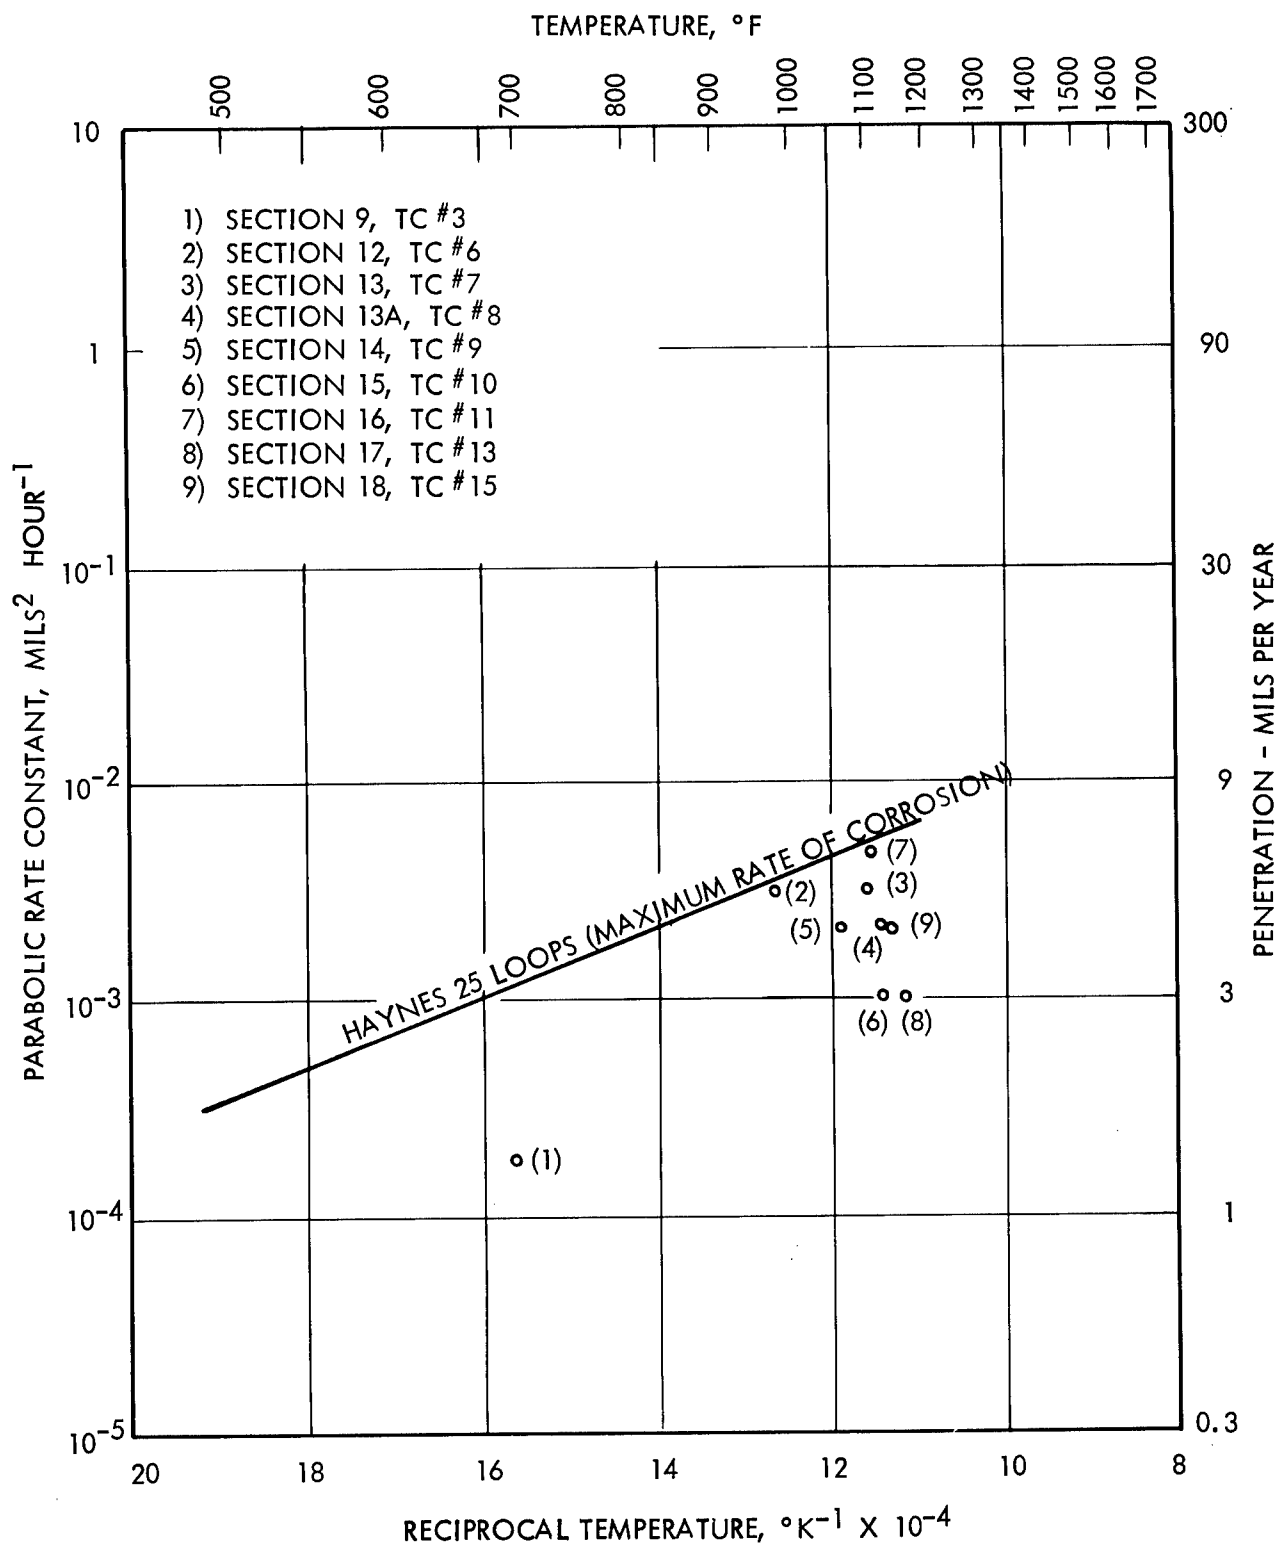
In general, the depth and mode of corrosion incurred in the boiler regions compare favorably with results obtained from previous corrosion tests. As shown in Figure 65, the attack incurred has been plotted as a function of the temperature. The results as plotted fall below or near to the curve, which is the maximum expected corrosion rate plotted as a function of the temperature (3).

However, the data, as plotted, should be used only for comparative purposes. As discussed with the results on metallographic examination, the temperatures listed for the various specimens are not truly representative of the total operating life. In view of this, the results seem to confirm the previous data on the corrosion of Haynes alloy No. 25 as obtained from thermal convection loops and capsule tests (2) (4).

FIGURE 65 COMPARISON OF HAYNES ALLOY NO. 25 MERCURY PENETRATION FROM THE WORK HORSE LOOP WITH TWO-PHASE THERMAL CONVECTION LOOPS
